# Manhole Inspection Summary

Manhole # S31GG2019MH

**Location** Address: **137 FIRESIDE CIR**

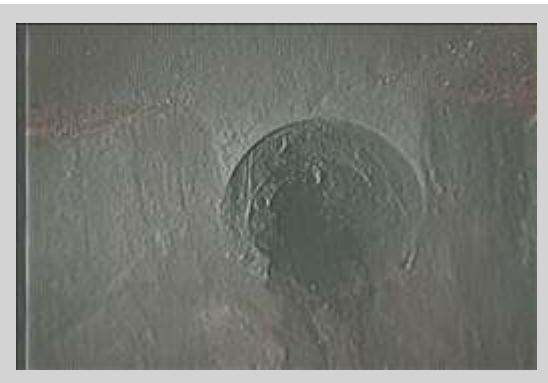
### 8 in. Circular Gravity Sewer Pipe In @ 3 O'Clock

Infiltration: **None** Pipe Seal Cond: **Unknown**

Connects To: **Dead End**

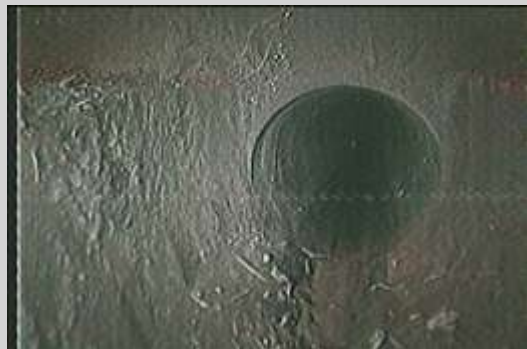
8 in. Circular Gravity Sewer

Infiltration: **None**
